An Overview of the On-Orbit Results from the Electric Propulsion Space Experiment (ESEX)

D.R. Bromaghim, J. R. LeDuc, R.M. Salasovich, G.G. Spanjers, and J.M. Fife

USAF Research Laboratory

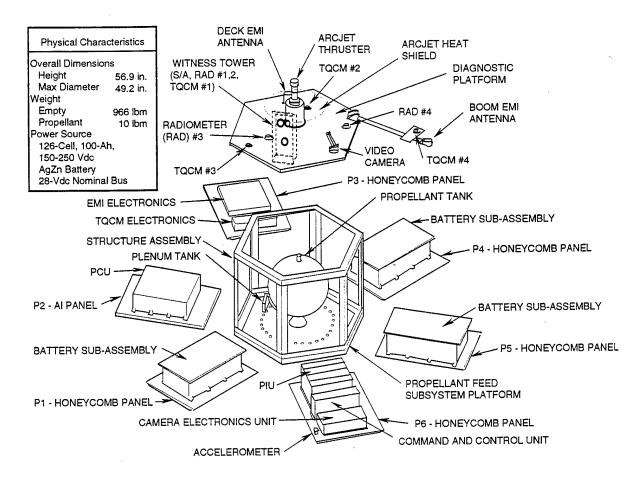
Figure 1

approximately 24 hours until, as subsequent analysis revealed, the battery sub-assembly on panel #1 (reference Figure 1) had a catastrophic failure. This failure was most likely a result of electrolyte leakage from one of the cells, causing a short circuit to the battery case. As the energy in the cell was discharging through the short circuit, there was a corresponding, dramatic increase in battery temperature, coupled with an increase in pressure as hydrogen gas was generated from decomposition of the electrolyte. This process continued until there was a breach of the battery case and a release of this super-heated gas internal to the ESEX flight unit. This gas was eventually vented into space, causing a dramatic attitude disturbance on the vehicle, resulting in a sunsafe event. A discussion on the contamination effects from the battery venting is described elsewhere.<sup>14</sup>

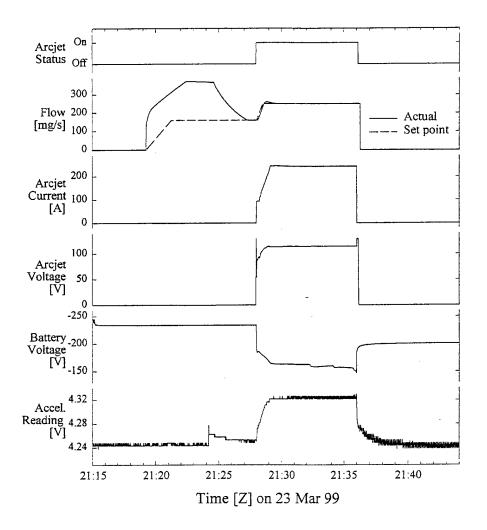
- Figure 1 Exploded view of the ESEX flight unit
- Figure 2 Typical operational profile of an arcjet firing showing the ramp to full power and steady-state operation

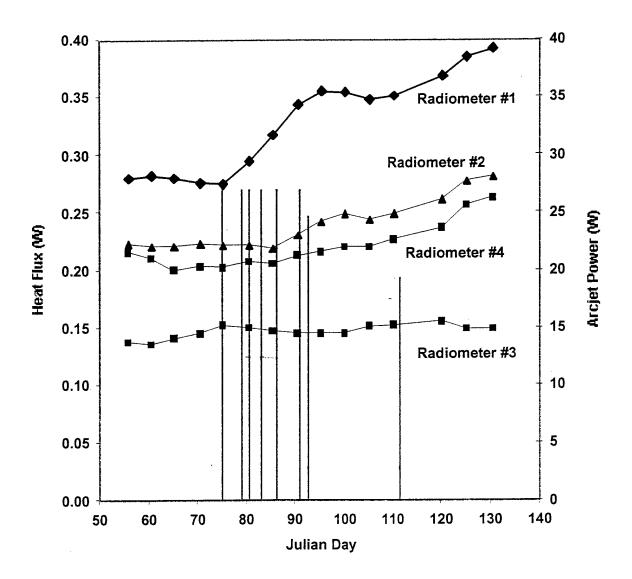
Figure 6 shows a summary of the maximum heat flux measured by the radiometers during the arcjet firing portion of the mission. Radiometer #1, placed near the thruster exit with a view of both the arcjet plume and body, shows an increase in the heat flux during this period, indicating a degradation of the sensor material from the arcjet firings. The other radiometers, which have no view of the arcjet, or a view of only the plume, show less degradation as a result of the arcjet firings.

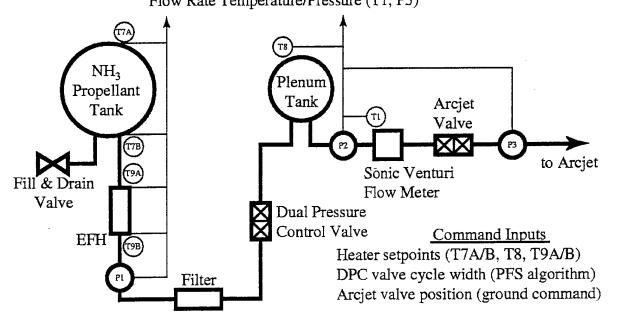
Figure 10

A schematic representation of the PFS is shown in Figure 10. The operational profile is presented in detail elsewhere <sup>6,16</sup> but basically consists of two heating periods prior to the outflow - one at t-17 hours, and one within minutes of the firing. This first heating period is to ensure sufficient pressure in the propellant tank to support flow, and the second is to heat the system to ensure the impending outflow to the arcjet is vaporized. The PFS algorithm is started just before the firing and controls the NH<sub>3</sub> flow rate by cycling the DPC valve to maintain pressure in the plenum tank corresponding to the specified flow rate. As a result of the software encoding, however, the DPC valve is cycled once at the start of the PFS algorithm regardless of the plenum tank pressure.

PFS heater performance prior to the outflows indicated that the bulk of the ammonia liquid remained away from the outlet of the propellant tank as the design intended. This was accomplished by differential heating of the propellant tank poles and was possibly aided by the angular momentum of the spacecraft in orbit. During the NH<sub>3</sub> outflow, and throughout the mission, temperatures of the enhanced feedline heater (EFH) indicated relatively little liquid entering the EFH, and 100% vapor outflow at the exit.

The liquid ingestion appears to be the result of a cold spot in the propellant line somewhere between the EFH and the DPC valve, likely a result of a cooler mounting platform than experienced during test. This platform temperature is not actively controlled, and can drift significantly, perhaps leading to a low enough temperature to condense NH<sub>3</sub> at the pressure in the propellant line. This cold spot allows NH<sub>3</sub> to condense and collect just upstream of the DPC valve. As described above, when the PFS algorithm is initiated, the DPC valve is cycled once, which releases this slug of liquefied NH<sub>3</sub> into the plenum tank resulting in the behavior described above. These data are supported by the fact that liquid ingestion was never observed during any steady-state operations of the PFS. To further support this hypothesis, there were some variations from the normal procedure on the last firing (F-8) and no liquid ingestion was observed. For this firing, the PFS heaters were turned on several days before the firing attempt while waiting for the battery reconditioning to complete. This increased the overall flight unit temperature 10-20 °F and may have eliminated the cold spot in the propellant line.

The liquid ingestion phenomenon was not readily observed in any of the ground tests. Initially, there were some minor differences between the flight operations profile and the ground test, primarily the heater setpoints and timing, but ultimately the flight profile was changed to mirror the test flow. This did not, however, alleviate the problem. Further modifications were made to the flight profile (mostly adjusting heater setpoints) but none of these changes proved successful either.

In summary, the liquid ingestion proved to be an annoyance, but did not seriously detract from the arcjet operation. If the ESEX mission had continued, a heater configuration that alleviated this problem would almost certainly have been identified. Other than this issue, the PFS performed within specification and, in general, operated exceptionally well. The flow rate control generally operated to within  $\pm 0.3$  mg/sec at steady-state conditions, which was more than an order of magnitude better than the requirement of  $\pm 5$  mg/sec. If this system evolved into an operational flight design, some heater power applied to the section of the propellant line in question, or more direct thermal control of that section, could almost certainly resolve the liquid ingestion issue entirely - especially in light of the results from the last firing.
